# SUBSIDENCE — A CRITICAL CHALLENGE TO FRIANT-KERN CANAL WATER DELIVERIES

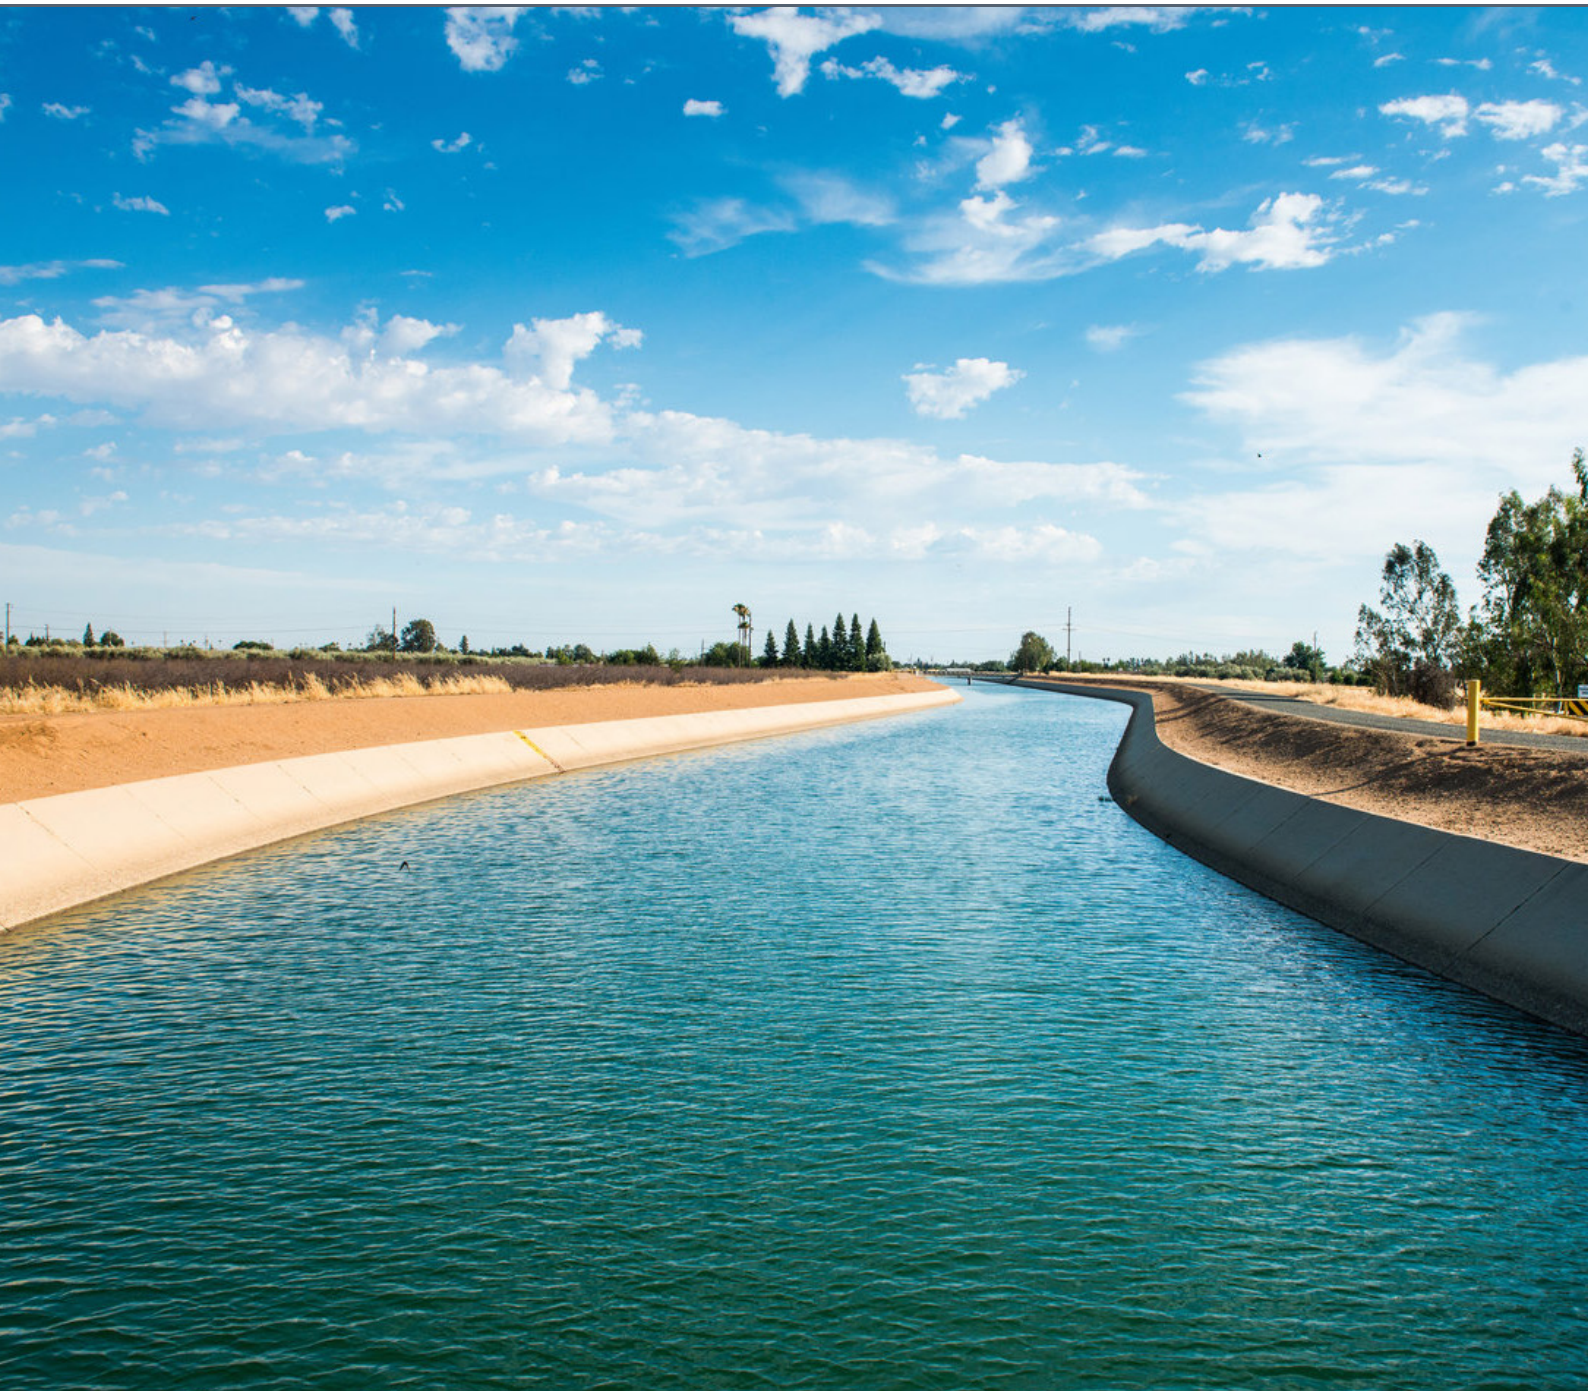
The picture on the previous page shows water passing under the bridge at Road 96 as it likely looked prior to the most recent subsidence. The picture on the left shows water hitting the bridge at Road 96 under similar flow conditions.

Evidence of subsidence was noticed when, at full capacity, water in the canal was running up against bridges it would normally pass under quite easily.
